## Accessibility of World Heritage Site:

### A survey of physical accessibility of Angkor Wat temple, Cambodia

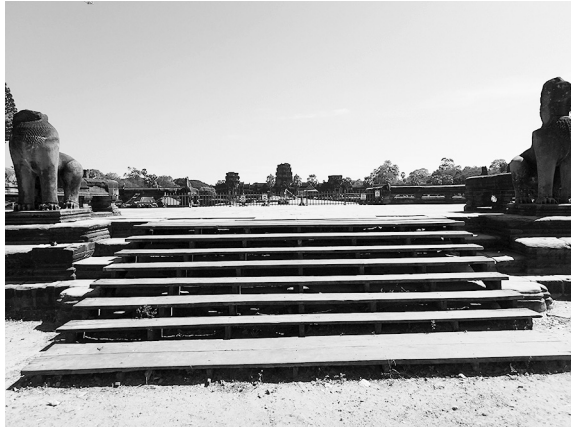
Results of measurement at the entrance to the western causeway, the west tower gates, the east side of retaining wall and the stairs of retaining wall are shown in Table 2. The stairs of entrance to western causeway were compliant with the criteria, but there was no ramp for wheelchair users (Figure 2). The west tower gates can be accessed from each of the five gates,

Figure 2: The stairs of entrance to western causeway (Point (1))

with minimal construction based on the results of this survey. As for the entrance to the western causeway (indicated as (1) in Figure 1), which many visitors use as an entrance to the temple, the structure of the stairs meets the standards of Japanese law, and installation of a ramp is expected to further improve accessibility. The sandstone causeway leading to the west tower gates is currently under construction and a temporary floating bridge has been installed. Although the floating bridge was not included in this survey because it was temporarily installed, it is highly desirable that the renovated sandstone causeway is designed with consideration for accessibility, because visitors must pass through the sandstone causeway in order to visit the temple from the western entrance. For the west tower gates, it was confirmed that the structures of Gate (2) and Gate (6) are close to the criteria, but considering that many of the visitors who visit for sightseeing purposes come to take pictures of the upside-down Angkor Wat reflected in the sacred pond near Stairs (17), the installation of a ramp at Gate (6) would be the minimum and effective accessibility improvement. As for the stairs of the retaining wall, the only staircase (8) was found to meet the criteria. However, since most of the visitors, especially tourists, visit restaurants and souvenir shops near stairways (17), it is expected that few visitors use stairway (8). Therefore, it would be effective to install a ramp at the point of stairway

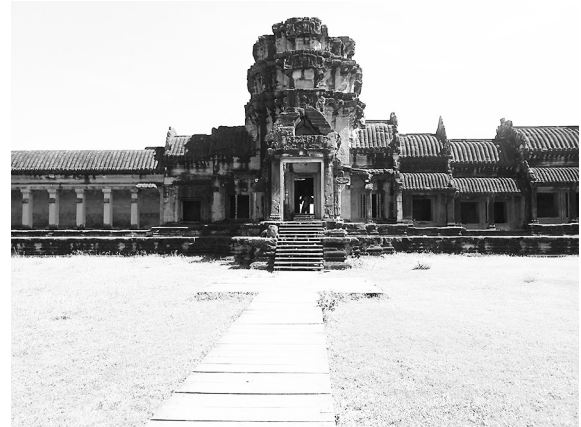
but gates (3), (4), and (5) were not included in the accessibility evaluation because a large statue of the deity was placed in the center of the passage inside the gate, and also because the number of steps in the staircase was much larger (Range: 13-17) than gates (2) and (6) (Figure 3). Each of the west tower gates has stairs on the east and west sides. For gates (2) and (6), it was confirmed that the structure was relatively close to the criteria (Figure 4). On the other hand, there are no ramps or flat walkways accessible to wheelchair users.

Figure 3: The west tower gate (Point (4))

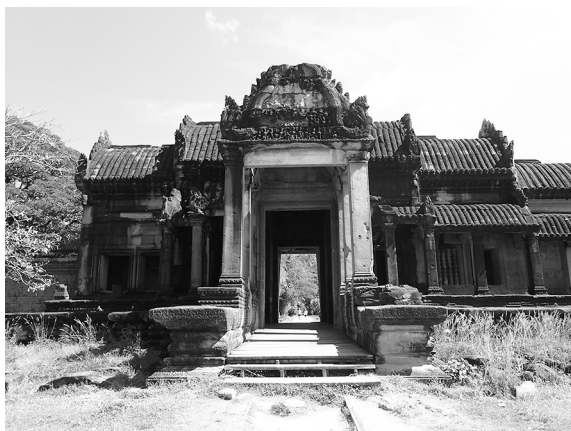
Figure 4: The west tower gate (Point (6))

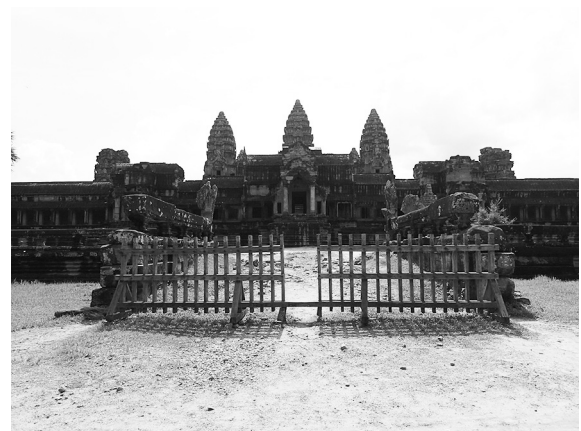
For the east side of the retaining wall (7), a wooden fence was installed, and the height and width of the accessible space in the center of the fence were measured (Figure 5).

The width of the space for passage was much lower than the criteria, and it was not possible for wheelchair users to pass through.

Figure 5: Wooden fence (Point (7))

(17), which is close to the sacred pond on the north side and also close to the restaurants and souvenir shops. A wooden fence was installed on the east side of the retaining wall, which made it difficult for wheelchair users to pass through. It is expected to be improved relatively easily with the installation of a new fence that meets accessibility standards. Regarding the restroom, it was found that some improvements are needed, especially in the width of the ramp. However, considering the route of visitors, the location of the restroom also needs to be considered. The current location of the restroom is on the south side of the temple, opposite the sacred pond, restaurants, and souvenir shops that many tourists visit. Considering the travel routes of visitors, it would be desirable to install a restroom that meets the criteria on the north side of the temple as well.

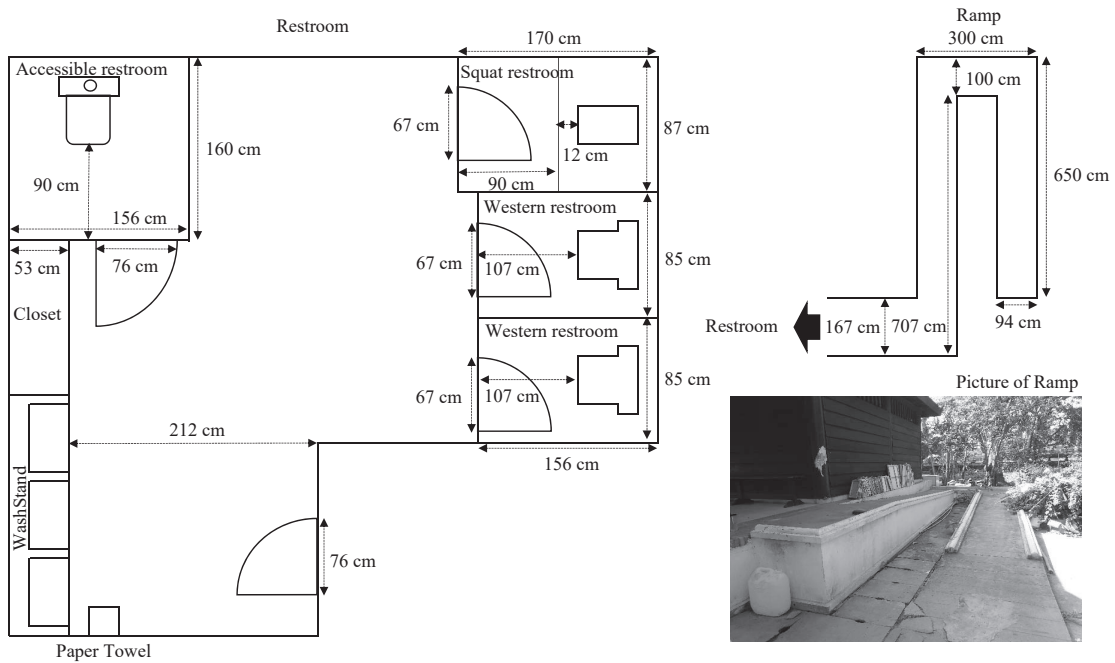
Results of measurement on the restroom for women and on the ramp leads to the restroom (18) are shown in Figure 6. The layout of restroom for men is almost the same as that of for women except for the kind of toilet. The restroom for men consists of three urinate, one squat toilet, one western toilet and one accessible toilet. Both the men's and women's restrooms had one accessible toilet. However, the width of the entrance and exit did not meet the criteria. Ramp (18) is installed beside the restroom. The gradient of the ramp is  $3.57^\circ$  and it was compliant with the criteria. However, there is no handrail installed, and the width of the slope is 94 cm, which is far below the criteria of 120 cm or more.

Figure 6: Structure of restroom and ramp
