## Accessibility of World Heritage Site:

### A survey of physical accessibility of Angkor Wat temple, Cambodia

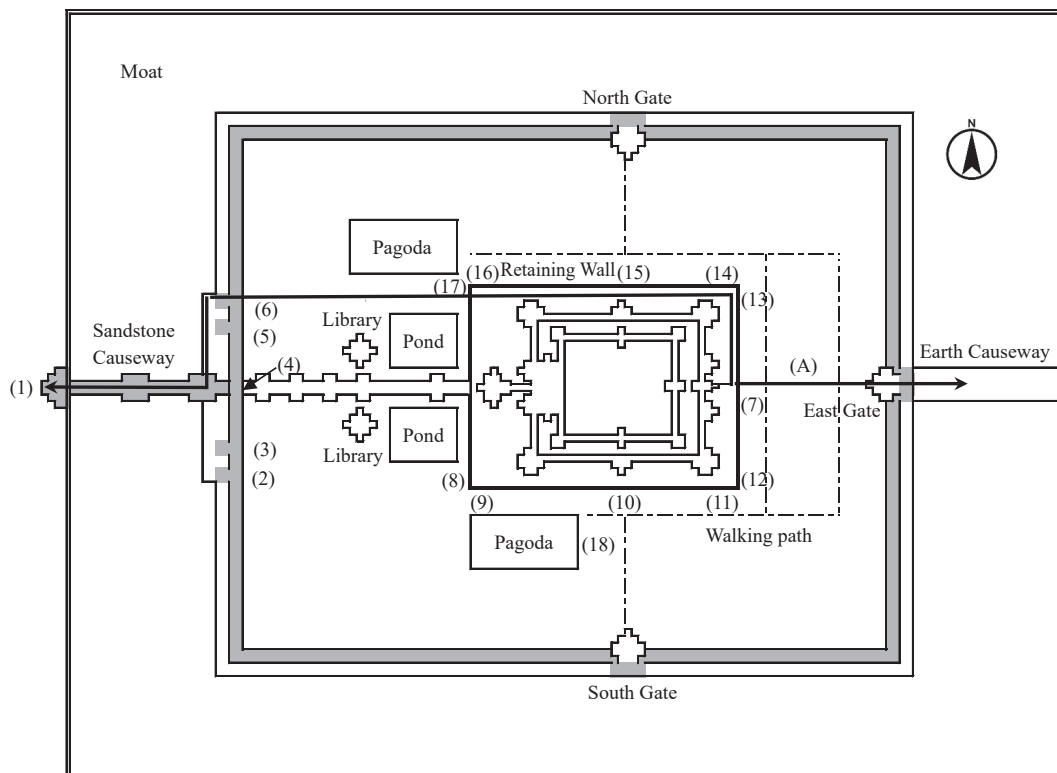
Figure 1: Survey spots

Survey spots are shown in Figure 1. A qualitative survey was conducted at five spots. Entrance to the western causeway

(1), which is used by a great number of visitors as an entrance to the Angkor Wat temple site. West tower gates (2), (3), (4), (5) and (6), that serve as entrances to the front approach to the temple. Eastside of retaining wall (7), that leads to the back approach to the temple. Stairs installed in the retaining wall (8), (9), (10), (11), (12), (13), (14), (15), (16) and (17) used for access to the inside of the temple. Finally restroom on the premises (18).

with minimal construction based on the results of this survey. As for the entrance to the western causeway (indicated as (1) in Figure 1), which many visitors use as an entrance to the temple, the structure of the stairs meets the standards of Japanese law, and installation of a ramp is expected to further improve accessibility. The sandstone causeway leading to the west tower gates is currently under construction and a temporary floating bridge has been installed. Although the floating bridge was not included in this survey because it was temporarily installed, it is highly desirable that the renovated sandstone causeway is designed with consideration for accessibility, because visitors must pass through the sandstone causeway in order to visit the temple from the western entrance. For the west tower gates, it was confirmed that the structures of Gate (2) and Gate (6) are close to the criteria, but considering that many of the visitors who visit for sightseeing purposes come to take pictures of the upside-down Angkor Wat reflected in the sacred pond near Stairs (17), the installation of a ramp at Gate (6) would be the minimum and effective accessibility improvement. As for the stairs of the retaining wall, the only staircase (8) was found to meet the criteria. However, since most of the visitors, especially tourists, visit restaurants and souvenir shops near stairways (17), it is expected that few visitors use stairway (8). Therefore, it would be effective to install a ramp at the point of stairway

With the improvements described above, the visitor's route indicated as (A) in Figure 1 is implemented. The development of this route is considered significant not only for the improvement of the accessibility of the Angkor Wat temple but also for the coexistence of tourists and local residents. This is because the route (A) facilitates access to tourist spots that attract tourists. In other words, the route (A) can be described as a tourism-oriented visitation route.
